# Home Inspection Report

**, 123 ELM STREET, LONG ISLAND - QUEENS**

**Date of Inspection: 5/2/2017**

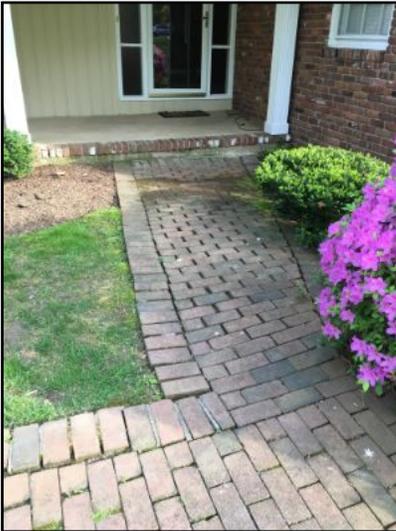
**Uneven Entrance Stone Walkway**

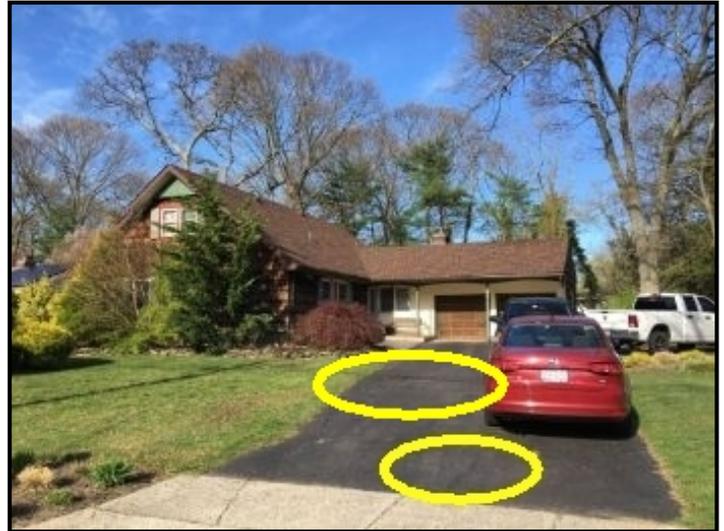
- Driveway in good shape for age and wear. No deficiencies noted.
- There are minor predictable and common cracks in the asphalt. Monitor these areas for further movement or expansion and repair/epoxy seal as needed.

**Typical Cracks in Asphalt Driveway**

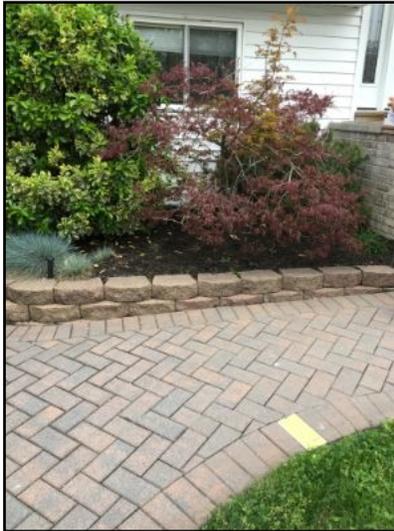
**Vegetation Abutting Exterior Wall**

- No major system safety or functional concerns noted at time of inspection.
- Maintenance Tip: When landscaping, keep plants, even at full growth, at least a foot (preferably 18 inches) from house siding and windows. Keep trees away from foundation and roof. Plants in contact or proximity to home can provide pathways for wood destroying insects, as well as abrade and damage siding, screens and roofs.
- The property has overgrown vegetation that needs to be landscaped. The front of home was maintained but the left side has overgrown bushes that are obscuring windows, the gas meter and the foundation.
- It is recommend to prune or remove any plants that are in contact or proximity to home to eliminate pathways of wood destroying insects.

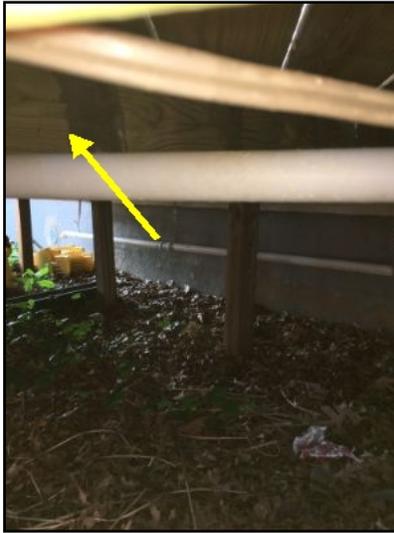
**Flashing Missing on Deck Ledger Board**

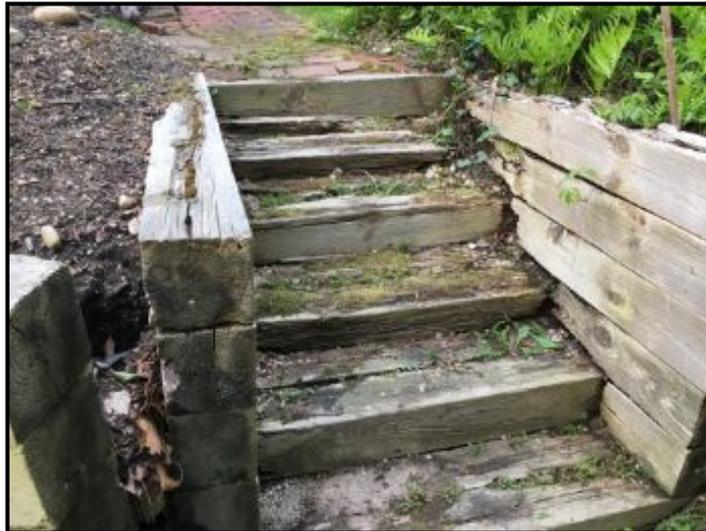
- **The rear exterior wooden stairway/retaining wall has rotted. These items should be replaced by a qualified contractor.**

**Rotted Rear Exterior Stairs and Retaining Wall**

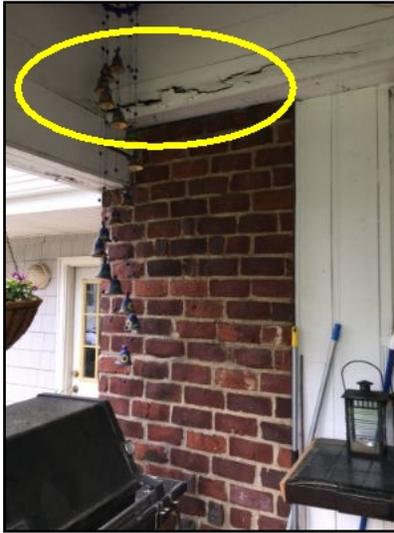
- **The main patio joist is highly rotted. It is recommended that a qualified roofing contractor evaluate the cause and repair as appropriate.**

**Moisture Intrusion Damage to Main Porch Joist**

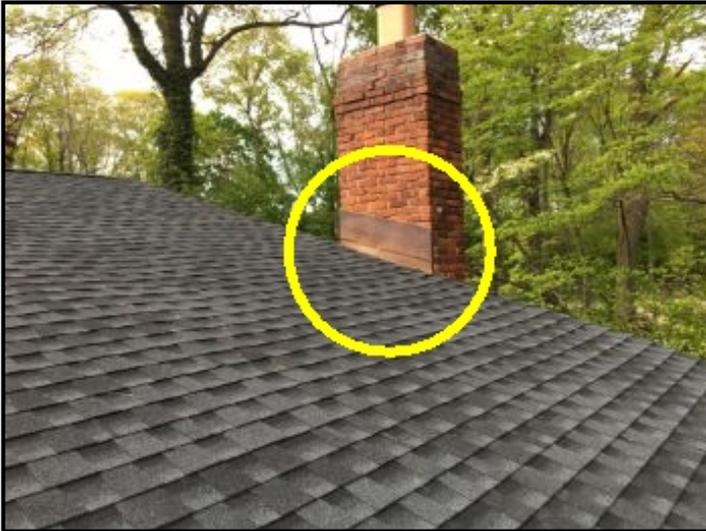
- **Step flashing was not apparent on western chimney. It is recommended that a qualified roofing contractor evaluate.**

**Step flashing Not Present on Western Chimney**

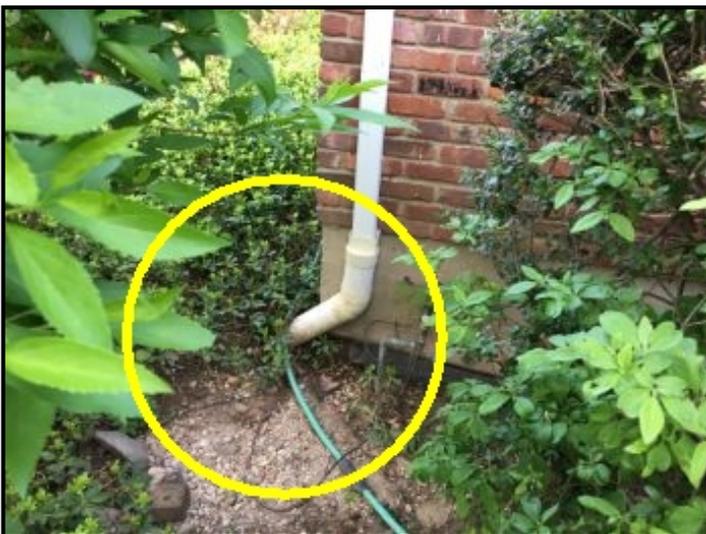
- **Extensions/splash blocks missing or insufficient. It is recommended to install them to divert water approximately 5 feet away from the foundation. Although no signs of past water intrusion into the basement were noted, diversion would be prudent to minimize any potential future intrusion.**
- **The gutter is installed to discharge directly to the lower roof can expedite erosion of the asphalt shingle surface. This area of the roof should be monitored for erosion.**

**Gutters Downspouts Too Near Structure**

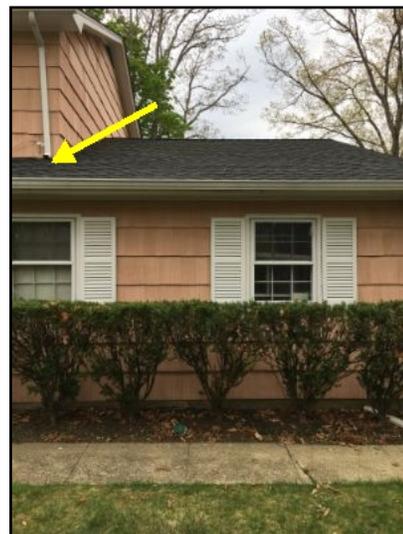
**Main Roof Downspout to Lower Roof Surface**

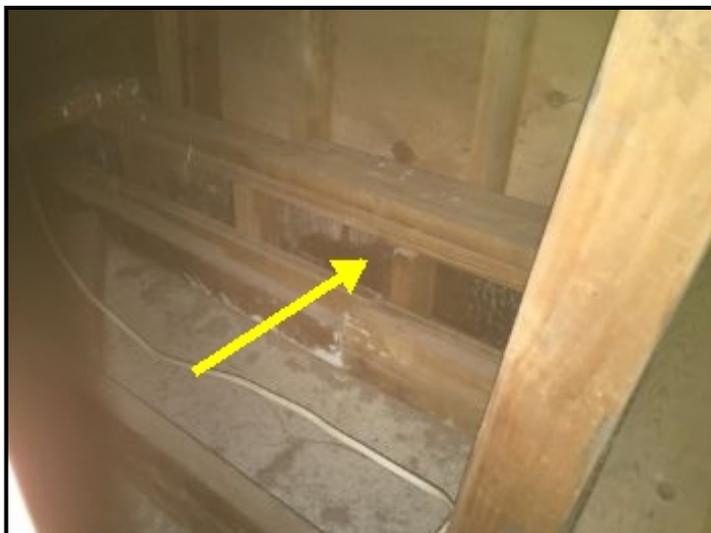
**Charred Surface of Attic End Rafter**

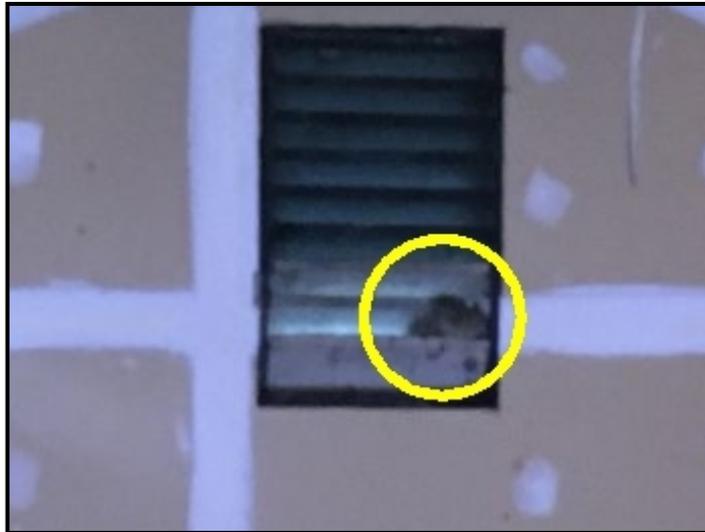
- **Functional. A hornet nest was observed in eastern gable vent. It should be safely removed to improve ventilation and eliminate nuisance issues.**

**Hornet Nest in Eastern Gable Vent**

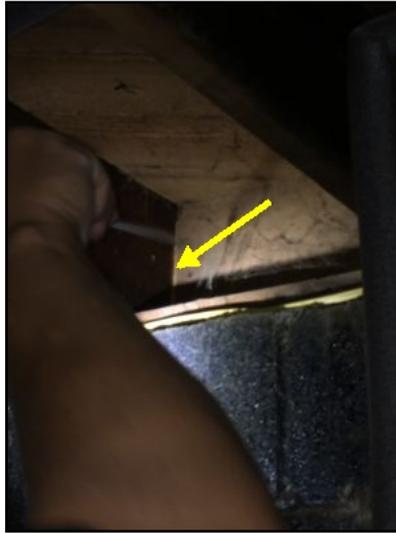
• **A termite tunnel was observed in northwest area of basement on joist corner. It is recommended that a qualified termite specialist evaluate.**

**Termite Tunnel In Northeast Corner of Basement**

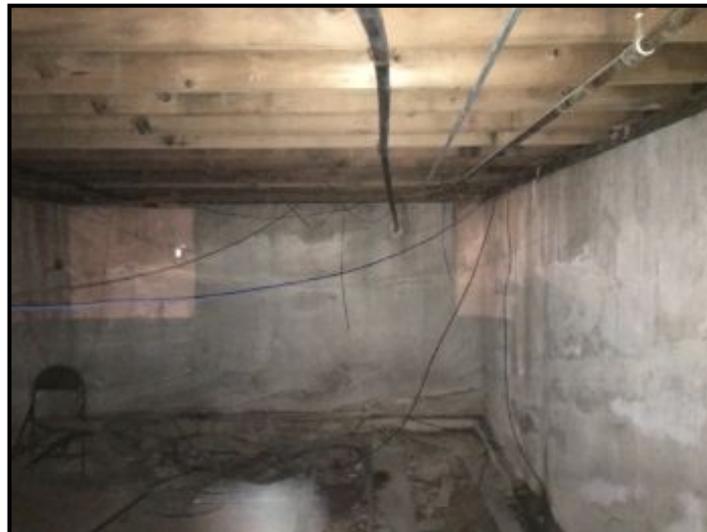
- Electrical wiring was observed not connected to basement ceiling.
- All wiring should be properly secured to the framing.

**Unfastened Wires in Basement**

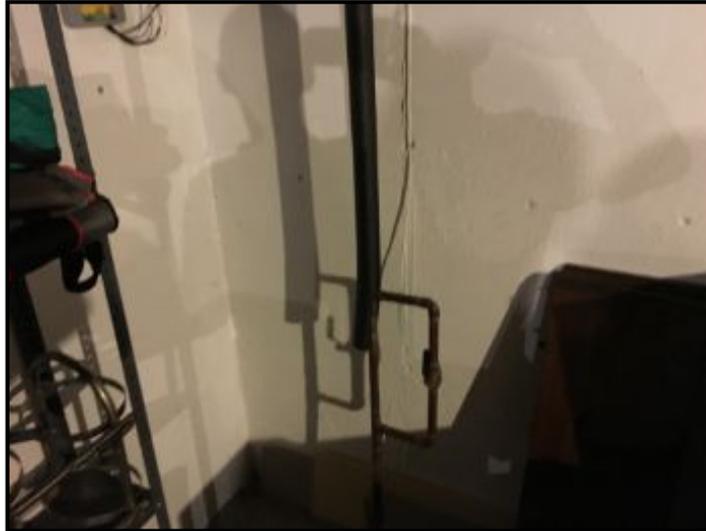
- **One sump pump was present in the southeastern corner of the basement. No pump was present in the sump. The owner had no knowledge of it ever operating or its purpose. There was no evidence of current or past moisture or water in the basement.**

**Basement Sump With No Pump**

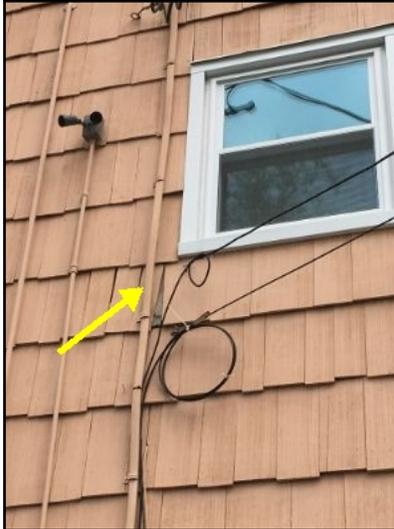
- **Condensate line insulation deteriorating. Replacement of insulation is recommended to increase cooling efficiency.**

**Deteriorated AC Supply Line**

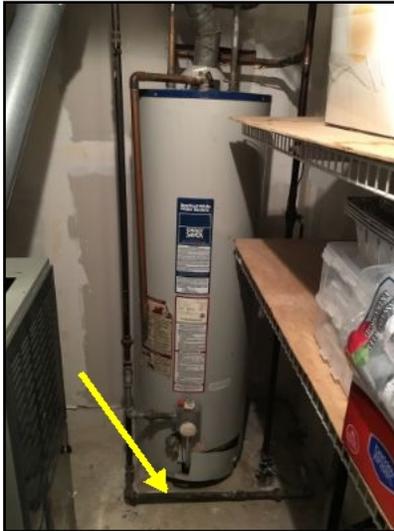
• The gas supply line was located in front of the heater on the floor. It is recommended that the line be relocated by a qualified contractor to avoid future damage to it.

**Inappropriate Gas Line Location of Water Heater**

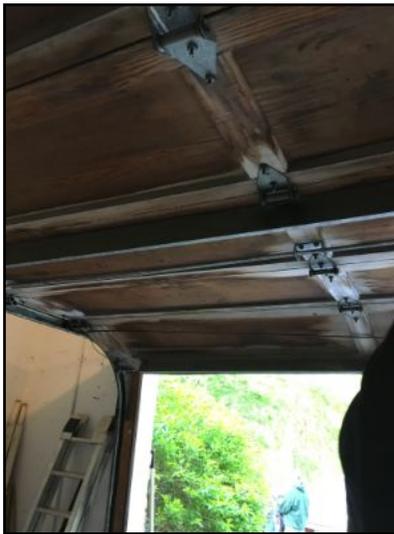
- **Mold-like material was observed on the door. it is recommend the affected areas be cleaned, such as with diluted muriatic acid, to remove the material.**

**Mold-like Materail on Garage Door**

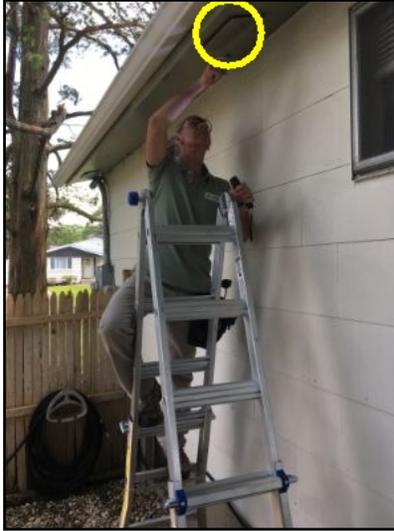
- **Some soffit vent screens have been painted over. It is recommended that the vents be cleared to allow for improved attic ventilation.**

**Soffit Vents Painted Over**

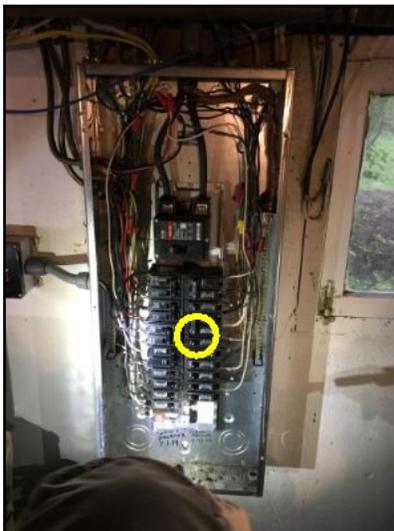
- **Double tapped breakers were noted in the main electrical panel.**
- **It is recommended that the breaker connections be evaluated by a licensed electrician.**

**Bridged Breakers in Main Panel**

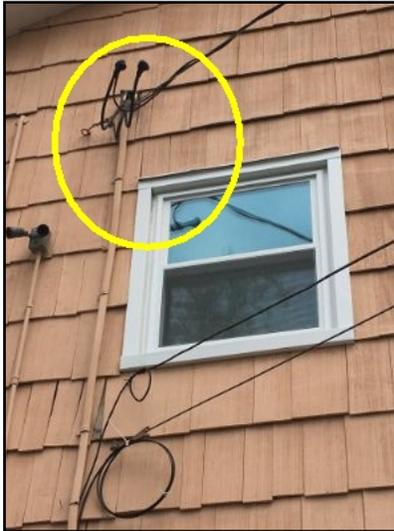
- **There is an overhead service drop is present on the south side of the structure.**
- **The service drop was located approximately 2 feet above the main bedroom window. This proximity should be evaluated by a qualified electrician, and discussed with the utility company, if warranted.**

**Electrical Drop in Close Proximity to Main Bedroom Window**

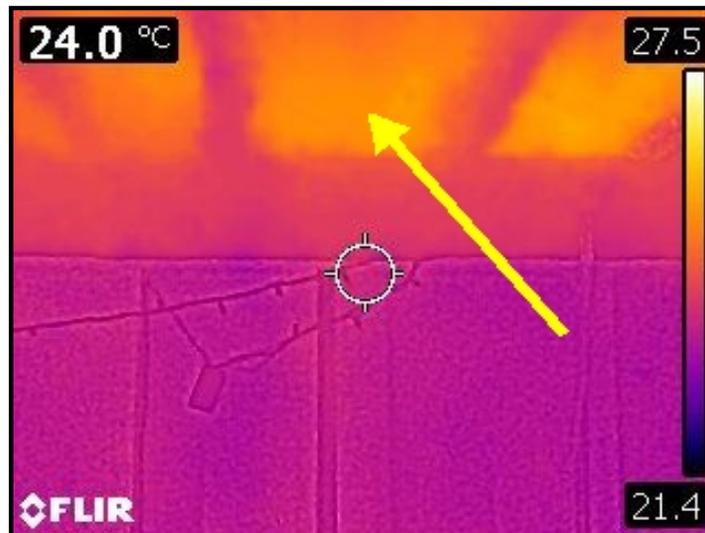
- Full view of foundation insulation was not available due to lack of access.
- Subfloor above finished basement area appears to have no insulation, as indicated by infrared camera image. Addition of insulation can increase air conditioning efficiency of this area.

**Lack of Insulation Above Finished Basement Portion**

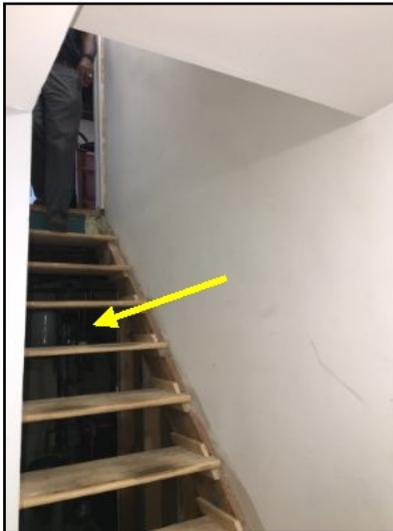
- Basement stairs did not have any solid back risers. Risers should be installed for safety purposes.

**Open Riser Basement Stairs**

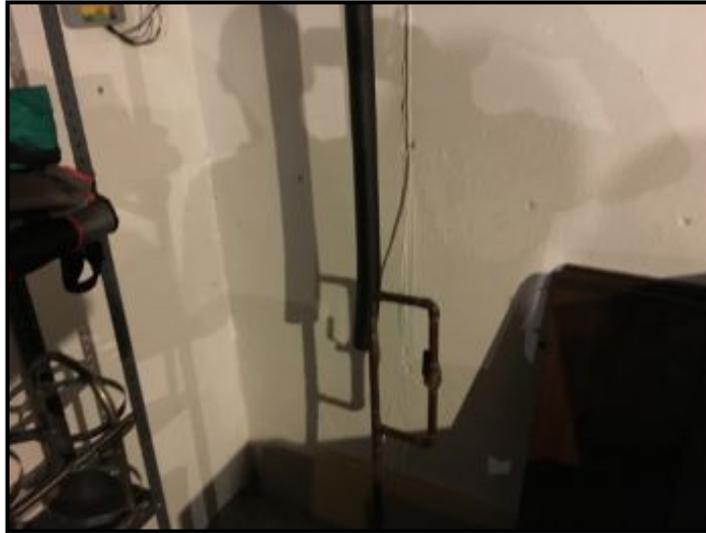
- A sump was present in teh southeastern corner of the basement, with no internal pump.

**Basement Sump With No Pump**
