# Home Inspection Report

**, 123 ELM STREET, LONG ISLAND - QUEENS**

**Date of Inspection: 5/2/2017**

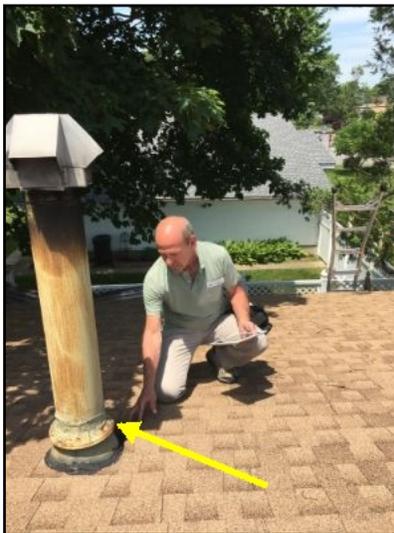
**Exhaust Roof Vent**

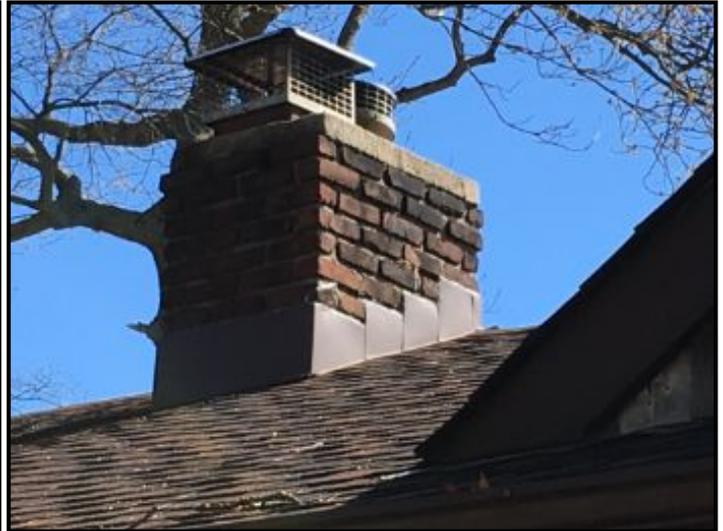
**Eastern Chimney**

- **Step flashing is not apparent on eastern chimney. It is recommended that a qualified roofing contractor evaluate.**

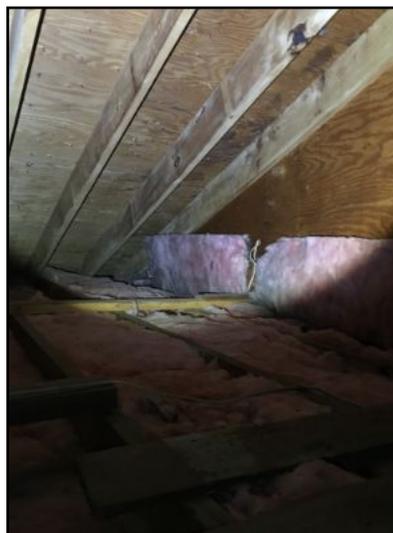
**Attic Rafters and Roof Sheathing**

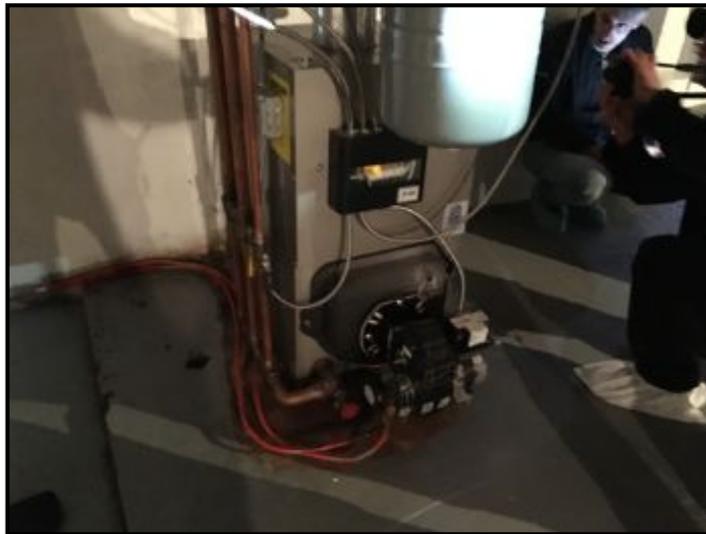
- **Unit does not have proper fireproof veneer above. It is recommended that one be installed.**
- **A 550-gallon aboveground oil tank was observed at the northeastern corner of the basement, with no apparent leakage at time of inspection. The Client is advised that these tanks are prone to corrosion and potential leakage. It is recommended that a qualified contractor evaluate the condition of the tank and associated piping.**

**2012: Argon**
